# OPERATION PLUMBBOB

Project 30.7

TEST OF GERMAN UNDERGROUND  
PERSONNEL SHELTERS

Issuance Date: June 25, 1962

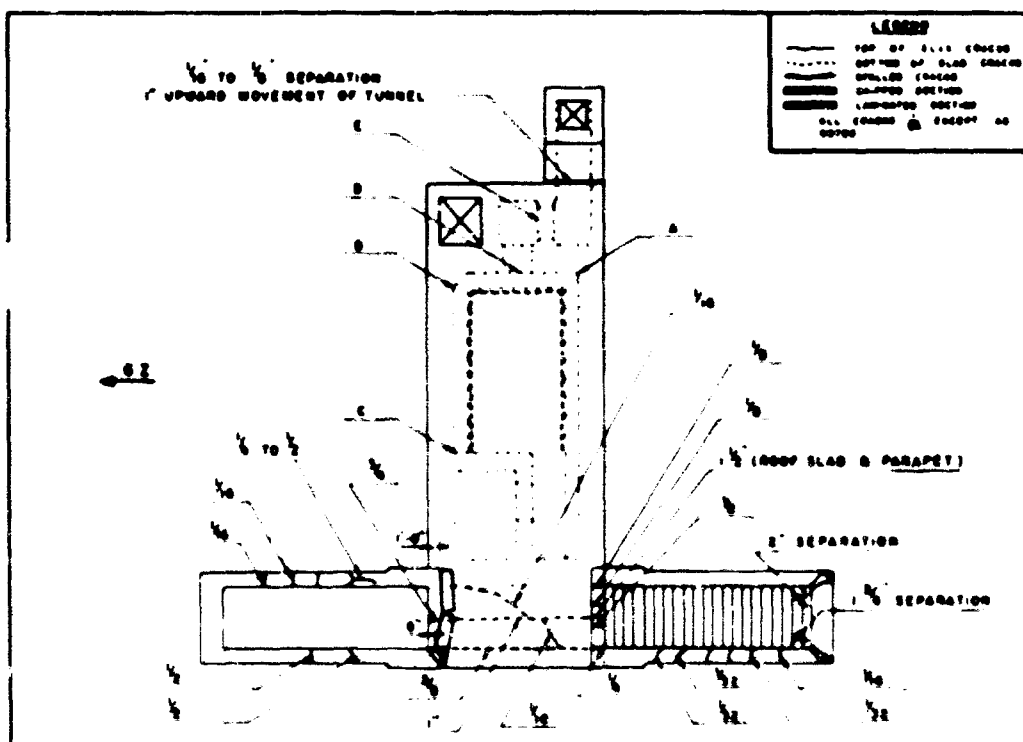
Fig. 3.1—Roof-slab crack pattern (structure RAa).

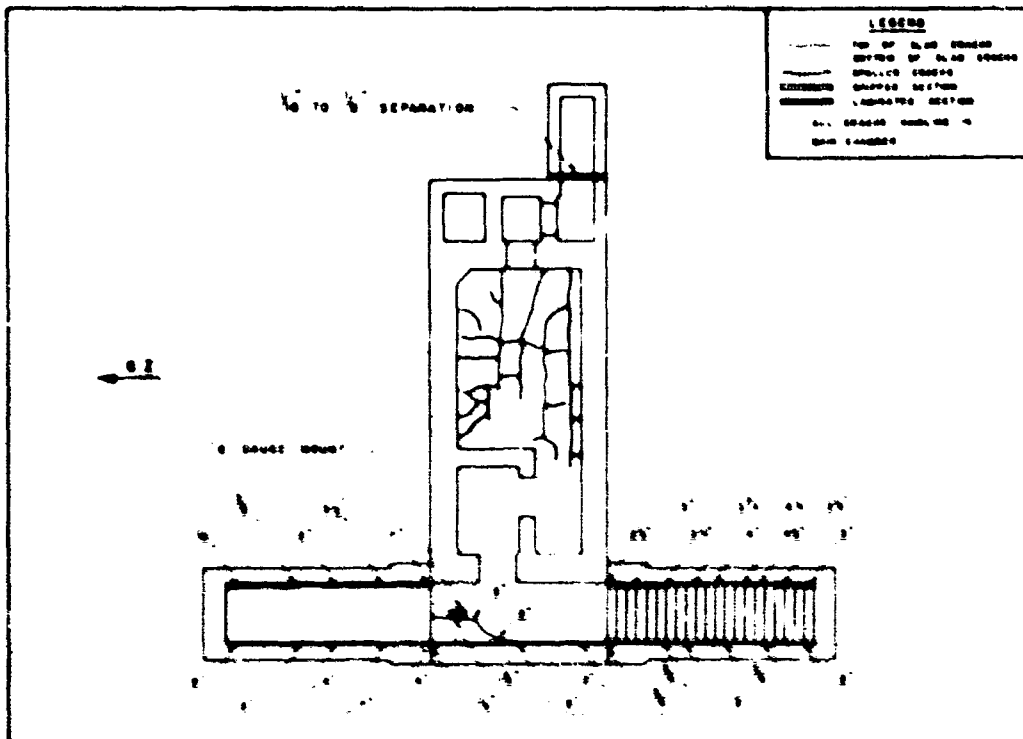
Fig. 3.2—Floor-slab crack pattern (structure RAa).

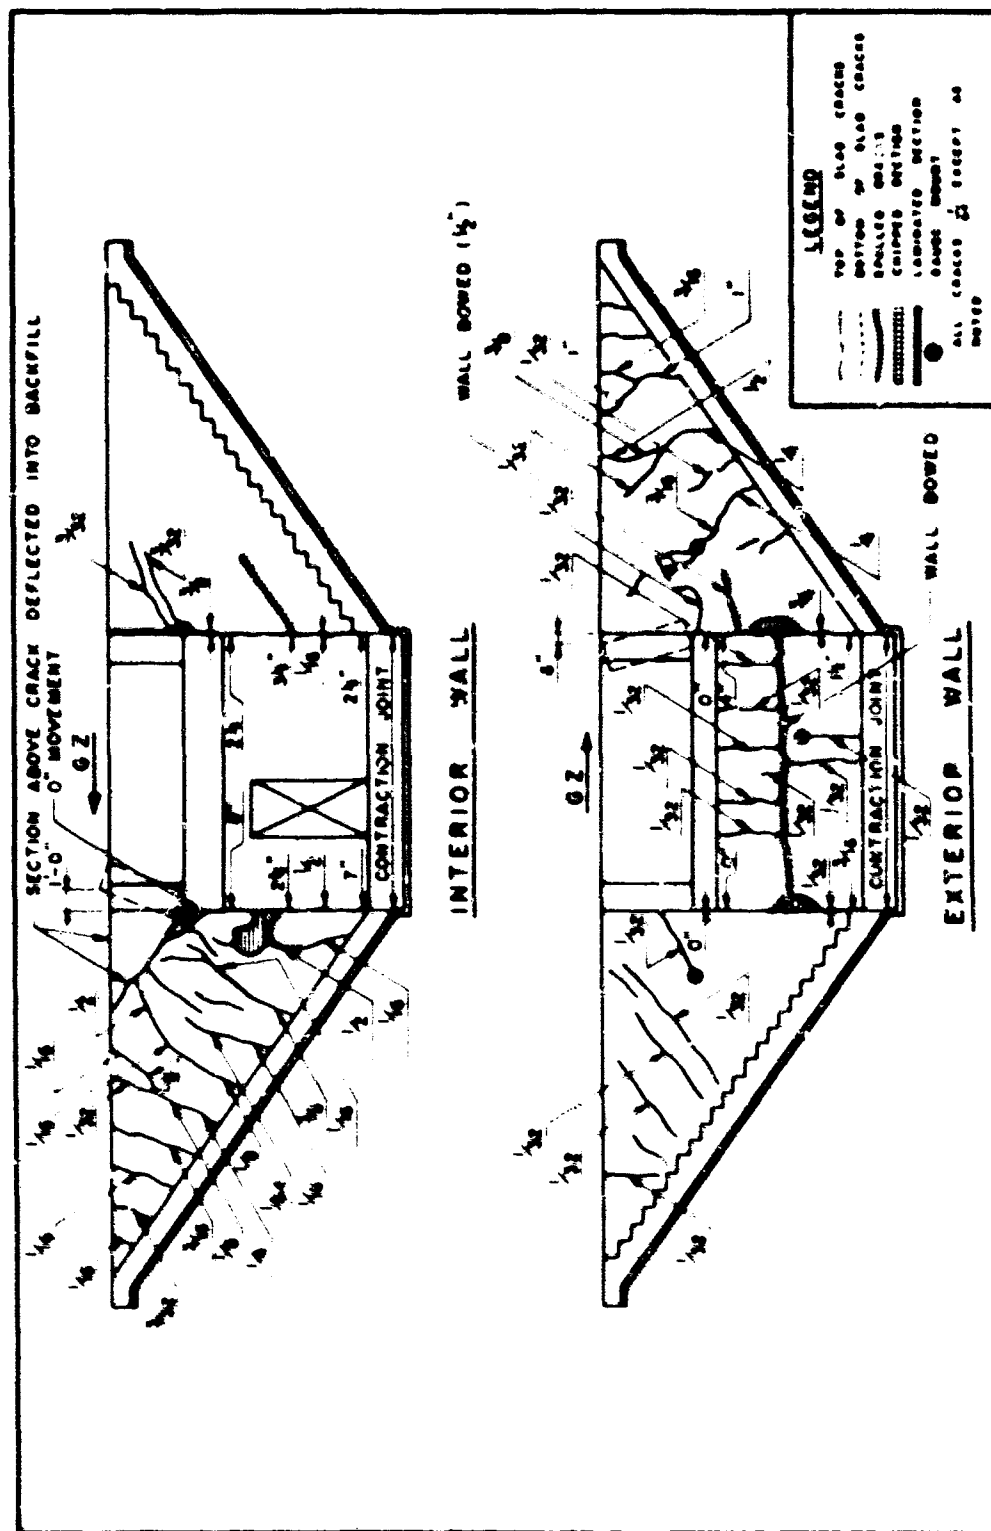
(a) *Entranceways.* In the ramp entrance facing GZ separations formed at the intersections of the interior and exterior walls with the ramp slab. The interior wall was pulled away from the slab 7 in. at the bottom and  $\frac{1}{16}$  in. at the top of the ramp. The intersection of the ramp and exterior wall was similar to that at the interior wall; that is, the crack varied from 4 to 7 in. near the bottom to zero inches at the top of the ramp. Bowing of the interior wall into the backfill was produced at the quarter-height along the contraction joint. A  $\frac{1}{16}$ - to  $\frac{1}{2}$ -in. vertical crack was formed near the bottom of the ramp. This crack terminated at a laminated area located at the mid-height of the wall. There was spalling on both sides at the upper section of the crack. Cracks varying from  $\frac{1}{16}$  to  $\frac{3}{8}$  in. in width, perpendicular to the plane of the ramp, were located approximately 2 ft on center along the length of the wall. The majority of these cracks ran the full height of the wall. A crack starting at a chipped-out section located at the intersection of the end of the roof slab and the interior wall ran diagonally toward the top of the wall. The section of the wall above this crack was deflected back into the fill. The exterior wall damage was similar to that described for the interior wall. A chipped section of the exterior ramp wall was located approximately 4 ft above the landing at the contraction joint. A horizontal crack, with spalling on both sides, above this section produced a  $\frac{1}{2}$ -in. bow in this wall. There were numerous diagonal cracks perpendicular to the plane of the ramp located approximately 2 to 3 ft on center in the upper two-thirds of wall. These cracks varied in size from  $\frac{1}{32}$  to 1 in. in width. The top of the parapet located above the landing roof slab that faces GZ was deflected into the backfill 6 in. at the intersection of the exterior wall and 1 ft at the interior wall. The corners of the parapet and side walls were chipped, and the reinforcement was exposed.

A 3-in. crack in the landing floor slab ran from the contraction joint at the bottom of the ramp along the center line of the slab to the Q-gauge mount. There it became a 2-in. crack, running diagonally to the exterior wall. A  $1\frac{1}{2}$ - to 2-in. crack was located along the intersection of the floor slab and the exterior wall. The crack was continuous the full length of the landing. The roof slab had a continuous longitudinal 1-in. crack along its center line. Two diagonal cracks  $\frac{1}{16}$  in. in width branched off the main crack, one terminating at the interior wall and the other at the exterior wall. A  $\frac{3}{4}$ -in. crack was produced along the intersection of the roof slab and the exterior wall. The exterior wall was badly damaged, having a longitudinal crack located at the mid-height of the wall. Spalling of 2 to 3 in. on each side was observed along its entire length.

Fig. 3.3—Entrance crack pattern (structure RAa).

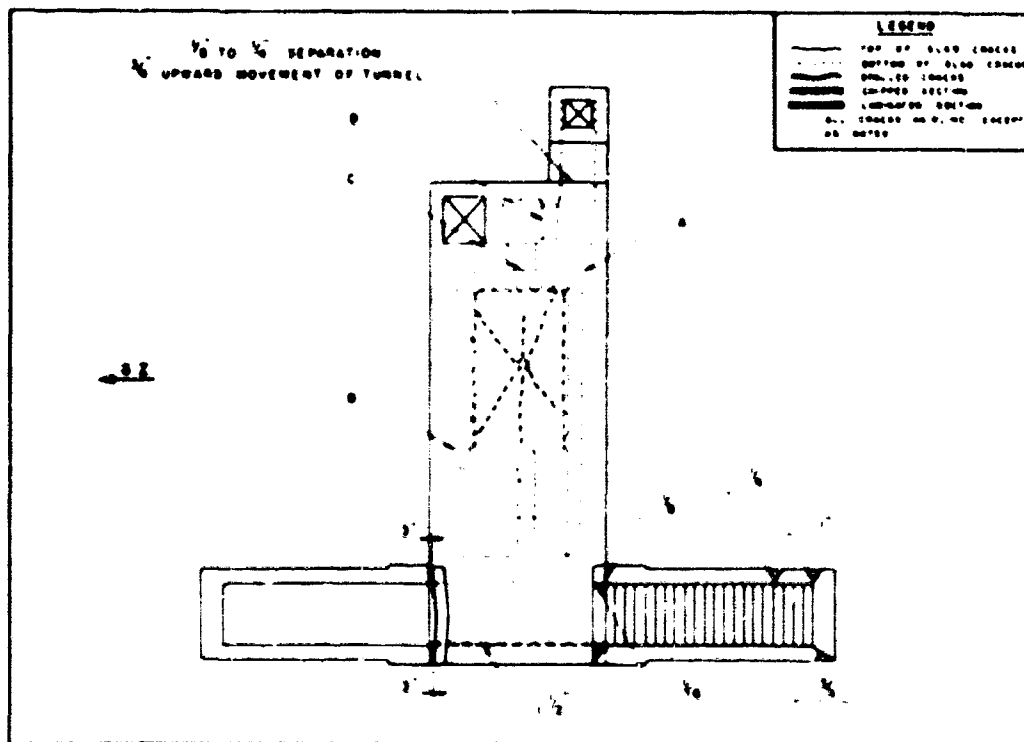
Fig. 3.25—Roof-slab crack pattern (structure RAB).

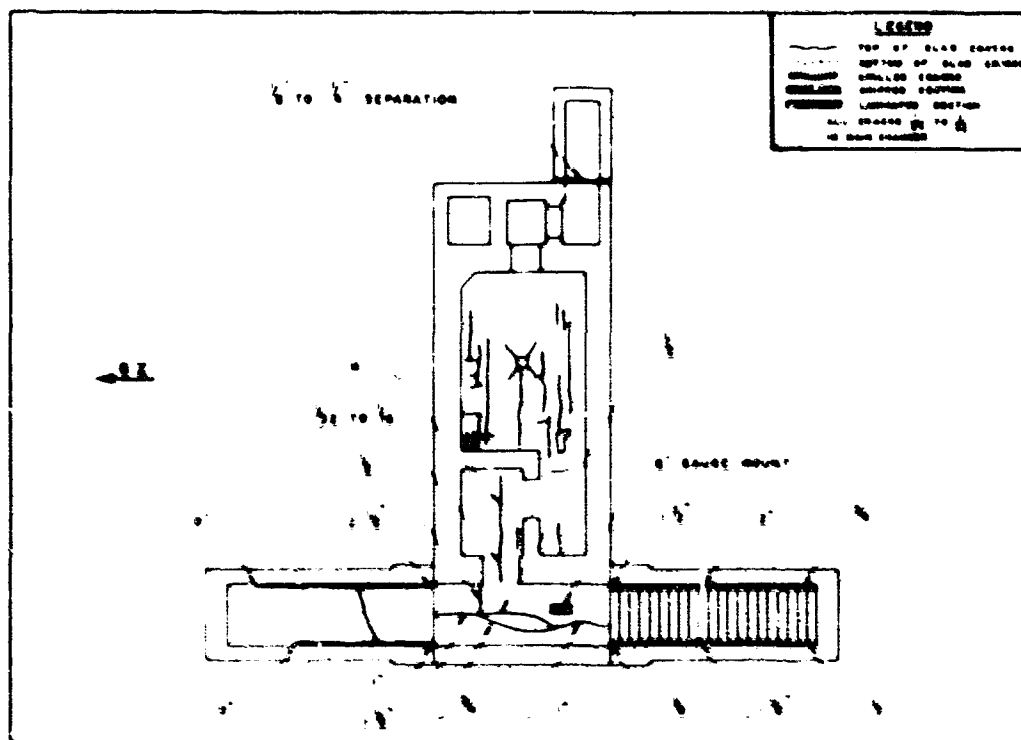
Fig. 3.26—Floor-slab crack pattern (structure RAB).

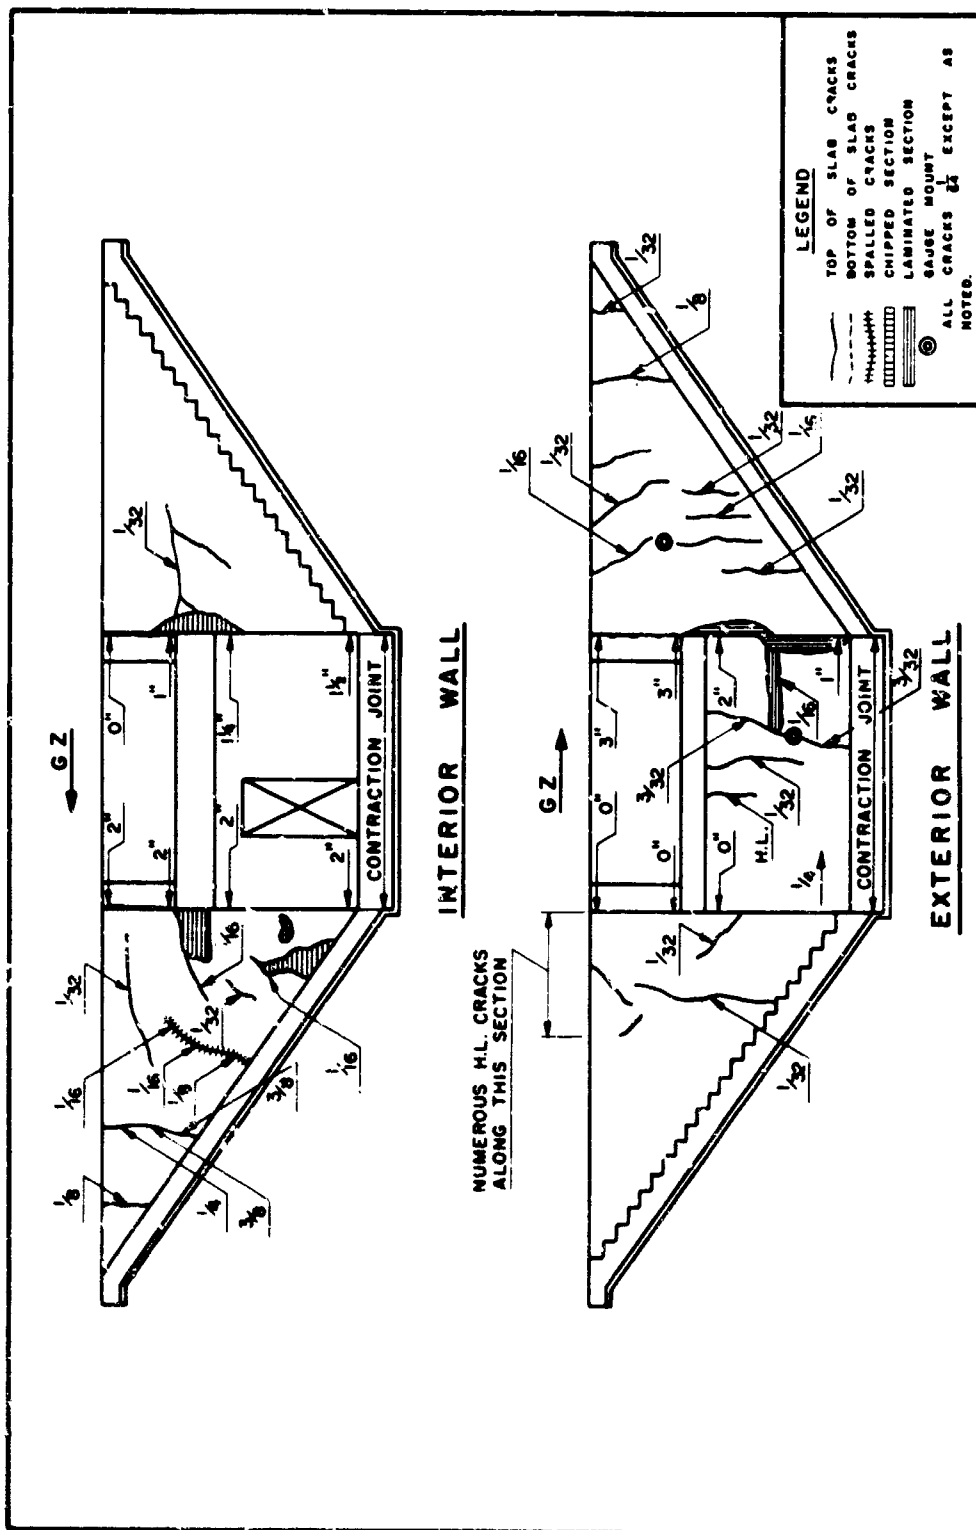
Fig. 3.27—Entrance crack pattern (structure RAb).

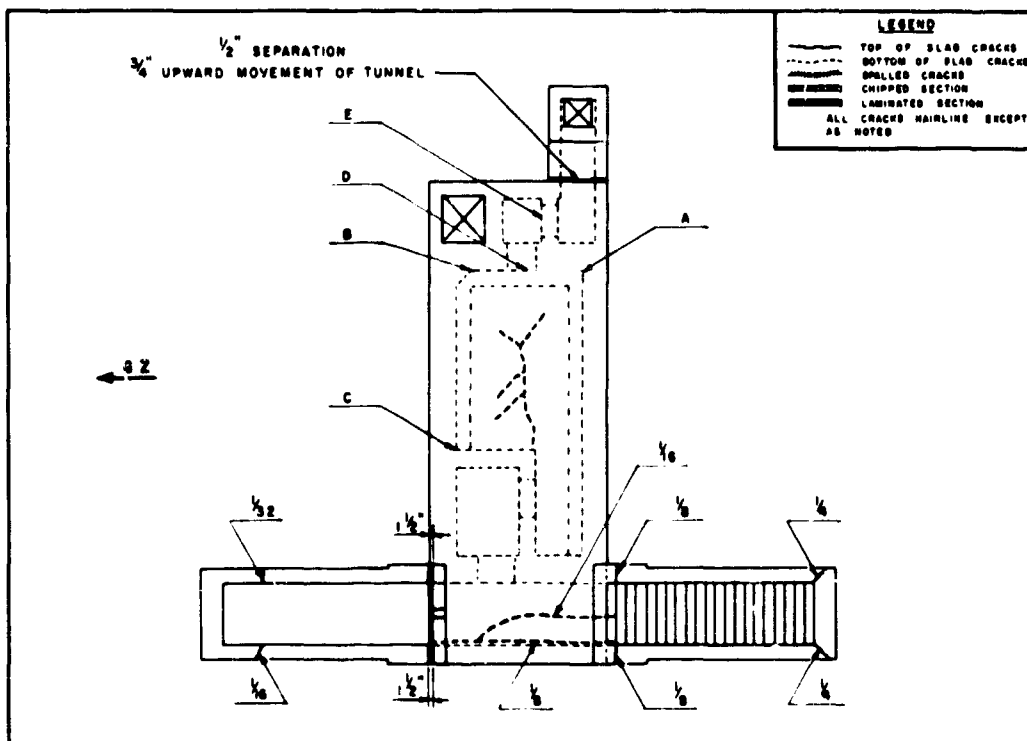
Fig. 3.33—Roof-slab crack pattern (structure RAc).

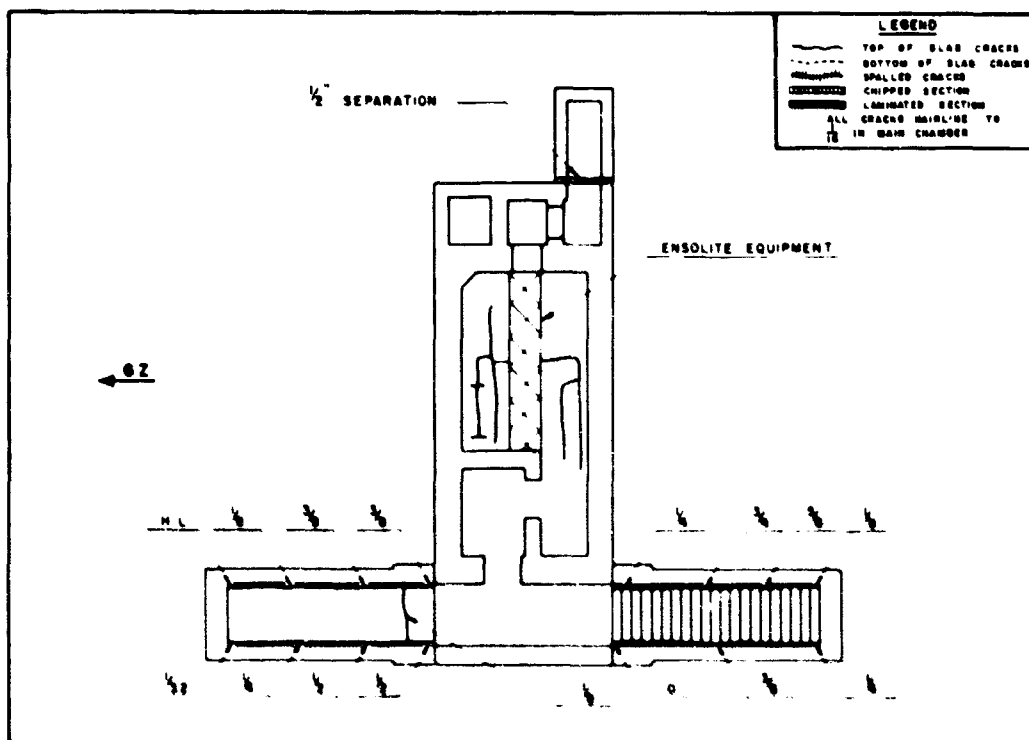
Fig. 3.34—Floor-slab crack pattern (structure RAc).

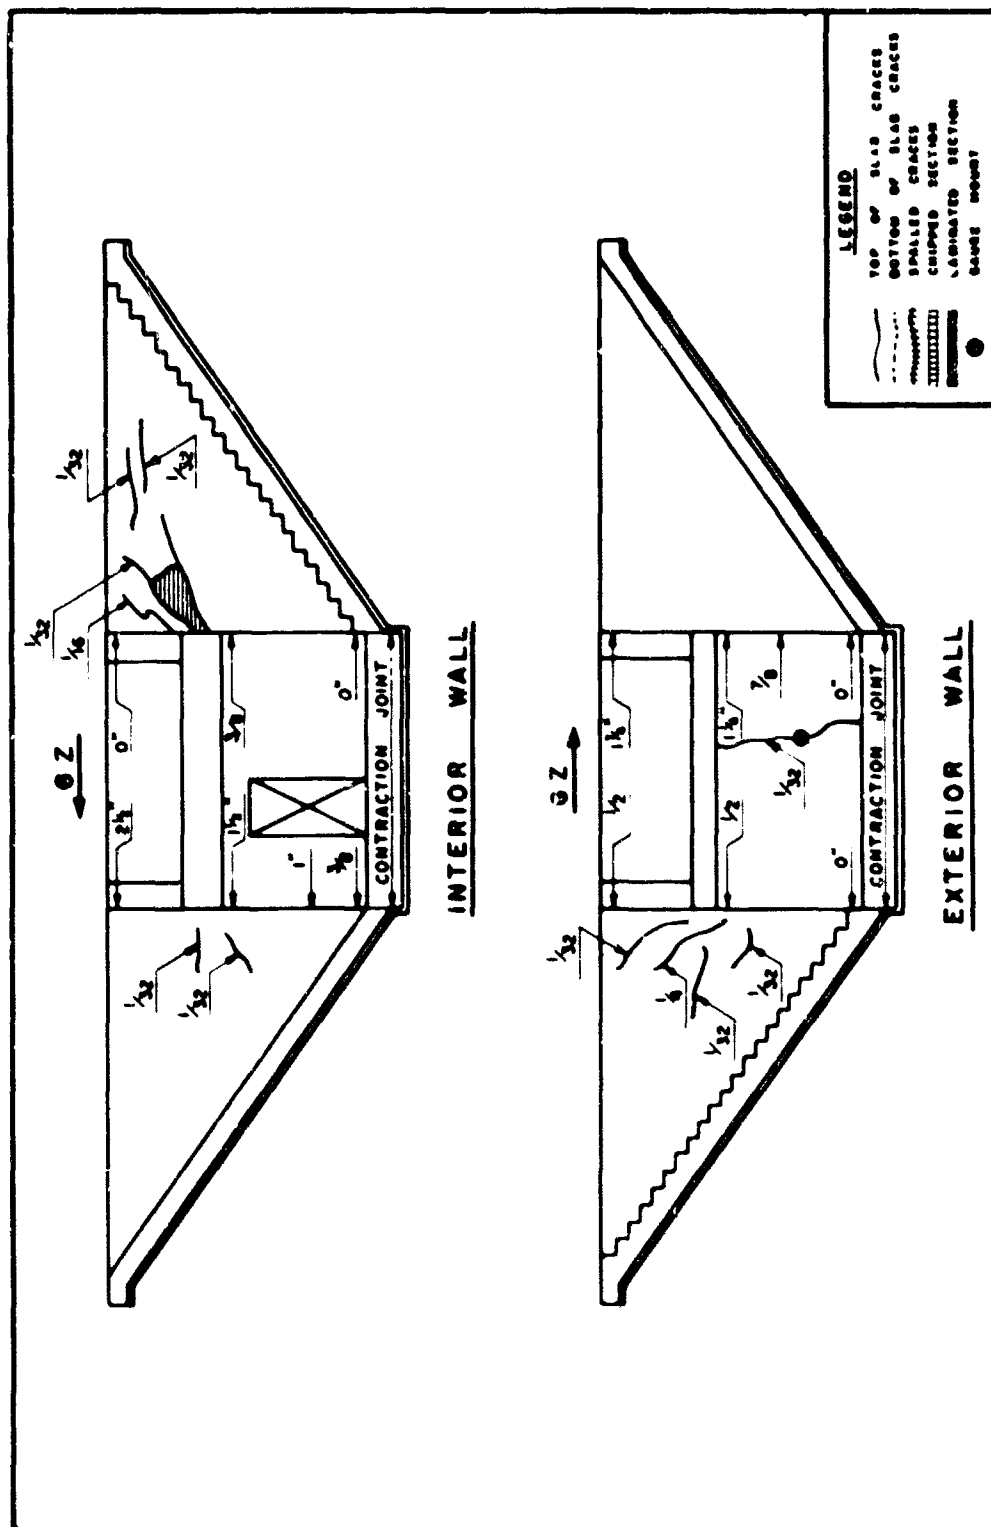
Fig. 3.35—Entrance crack pattern (structure RAc).

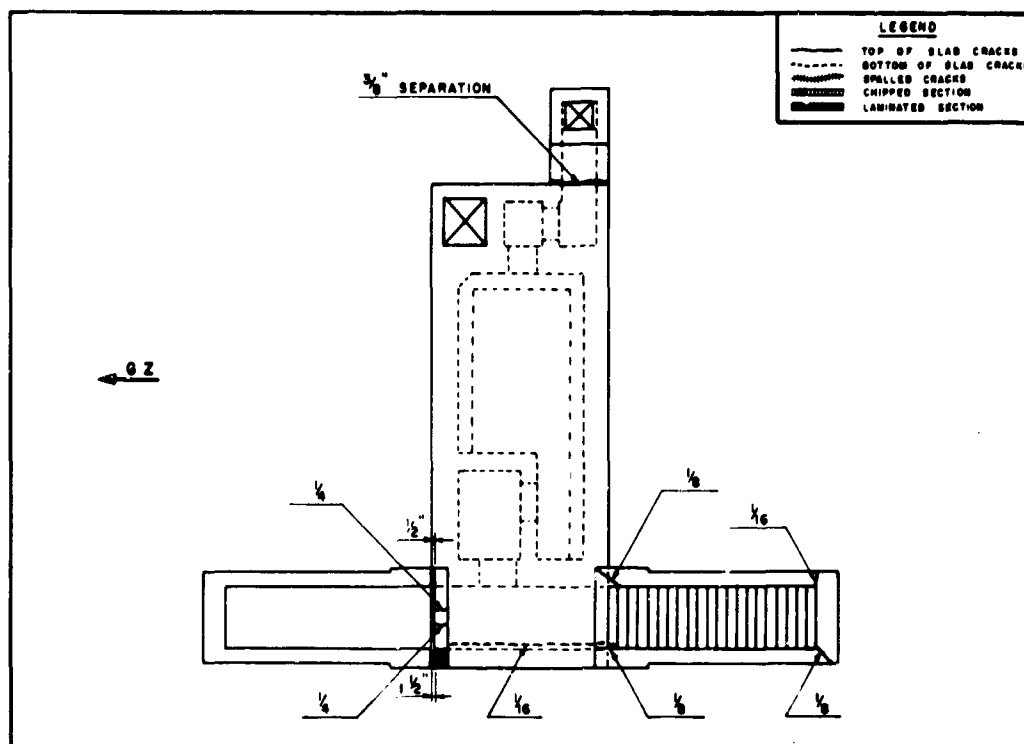
Fig. 3.54—Roof-slab crack pattern (structure RAD).

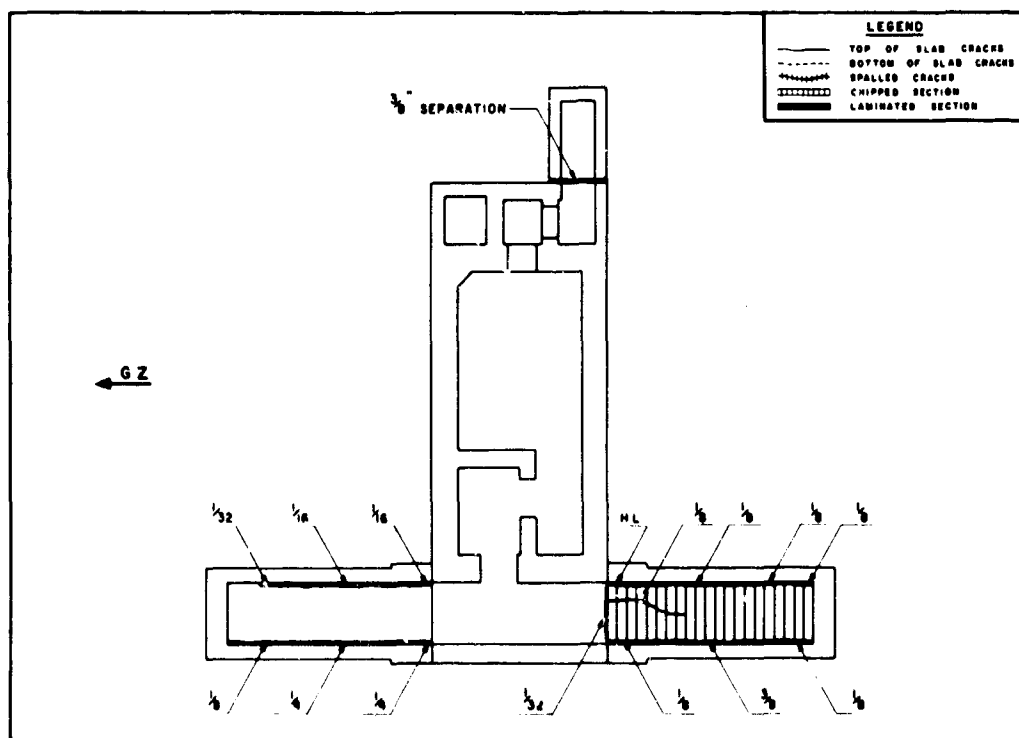
Fig. 3.55—Floor-slab crack pattern (structure RAD).

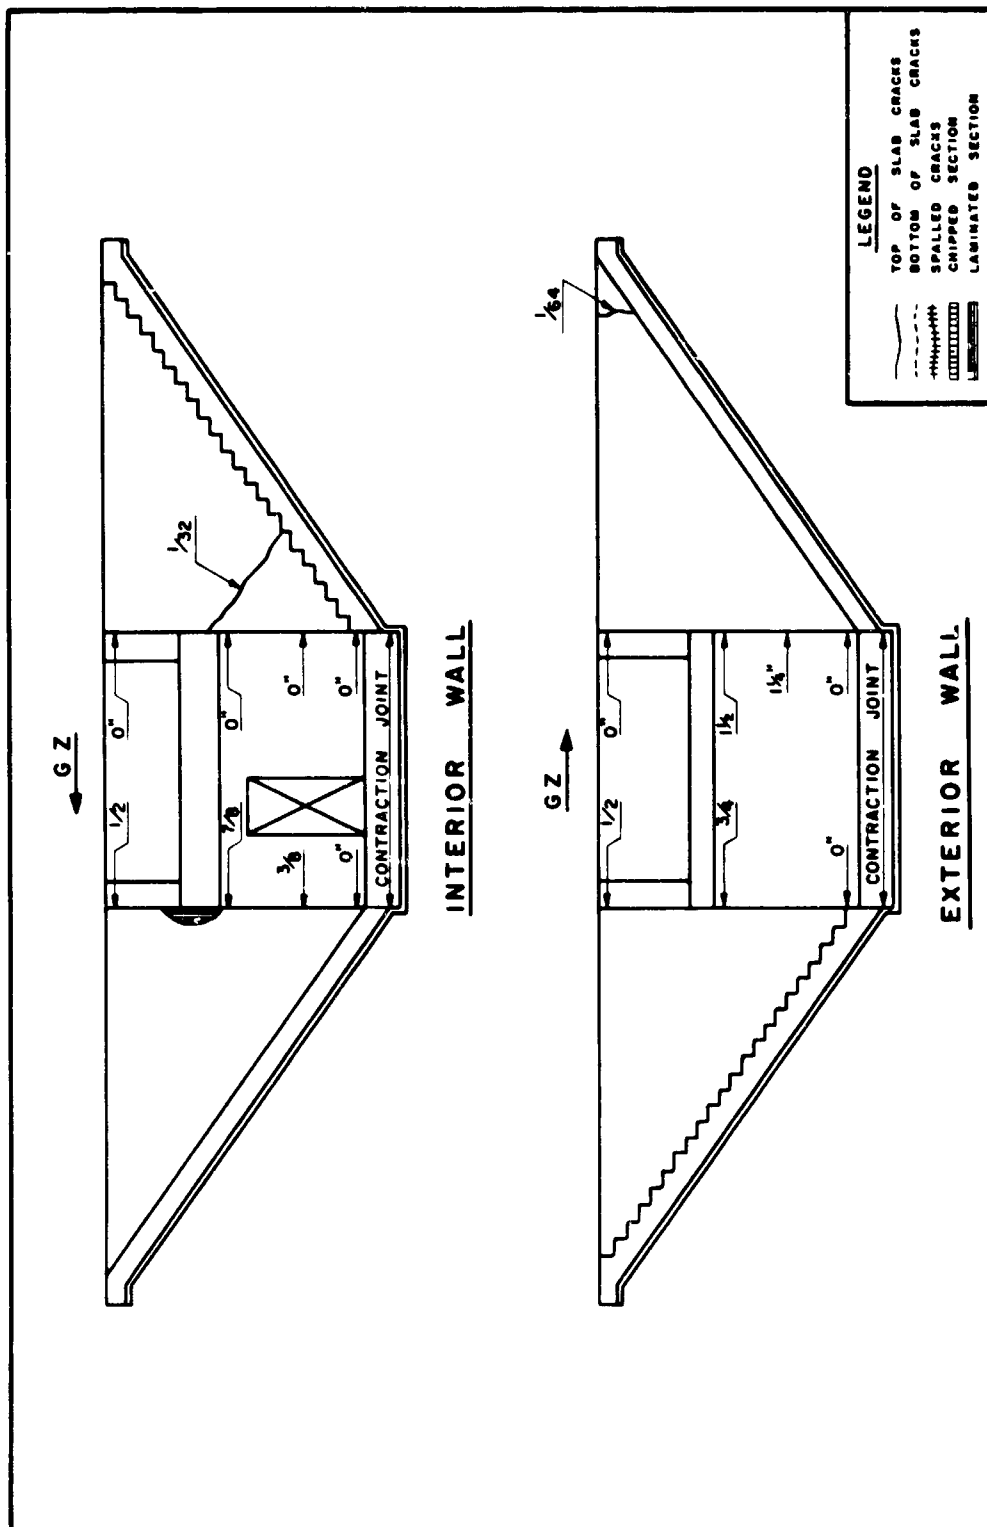
Fig. 3.56—Entrance crack pattern (structure RAD).

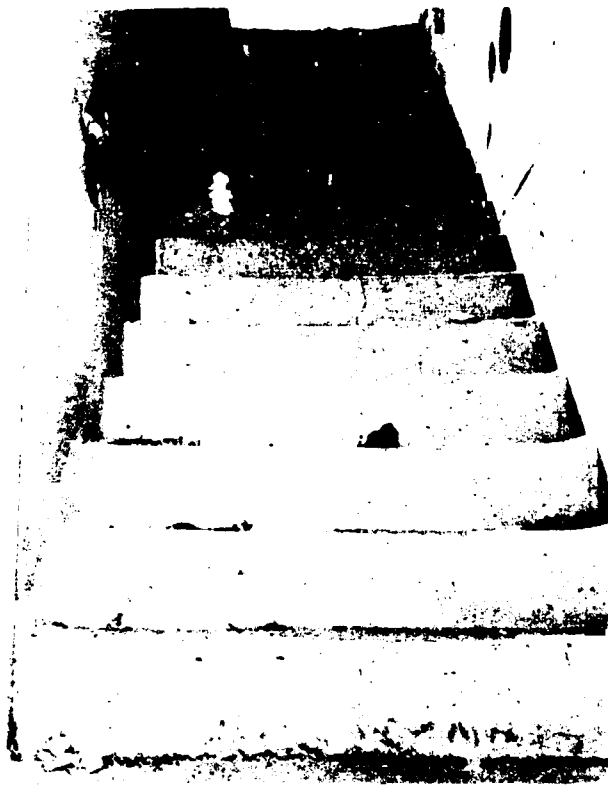
Fig. 3.71—Looking up stairs facing away from GZ (structure CAa). Note crack running up stairs and separation of construction joint.

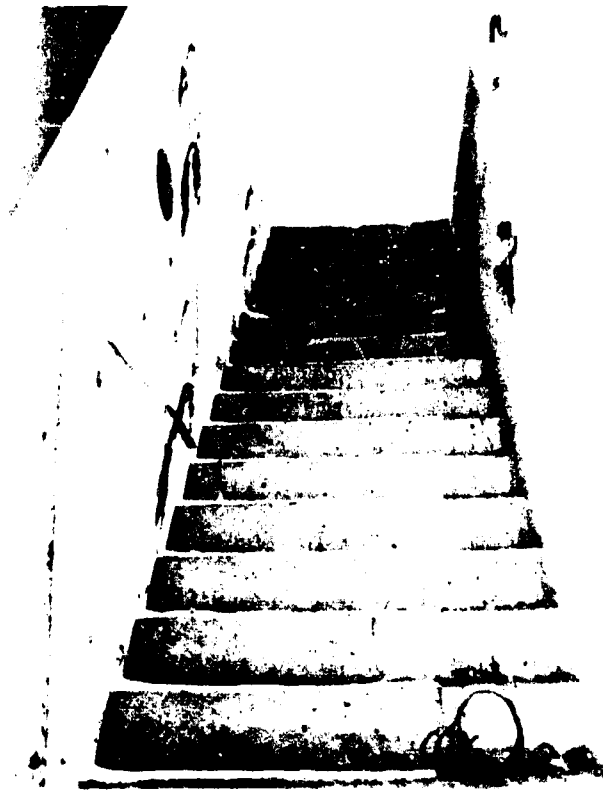
Fig. 3.80—Looking up stairs facing away from GZ (structure CAb). Note crack running up stairs.

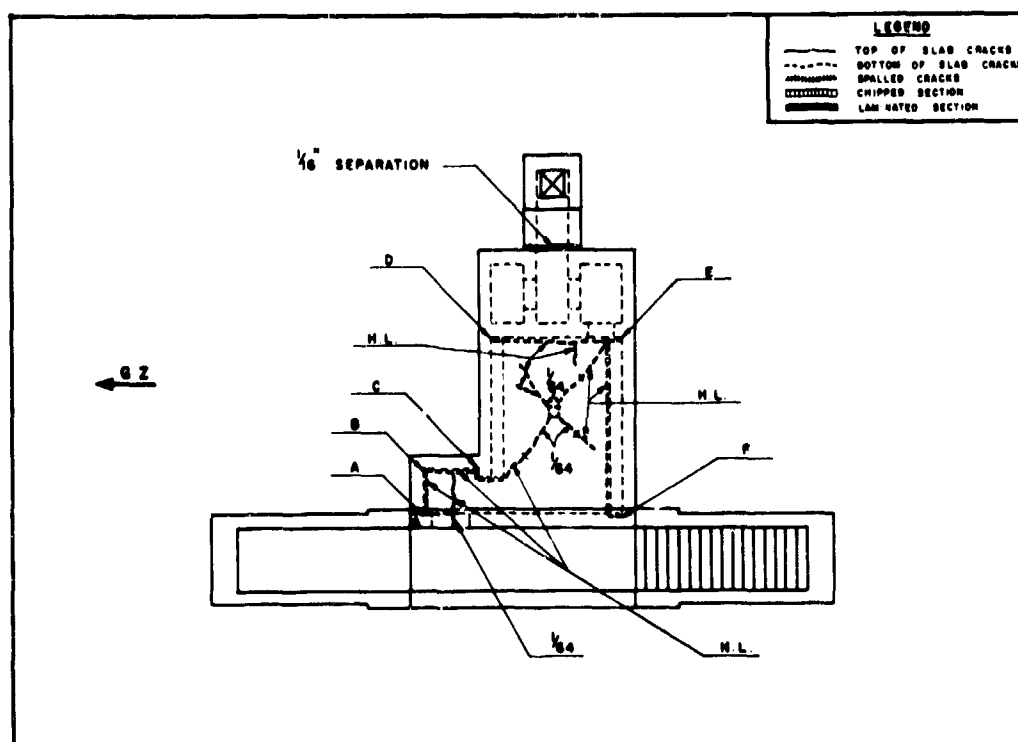
Fig. 3.82—Roof-slab crack pattern (structure RCa).

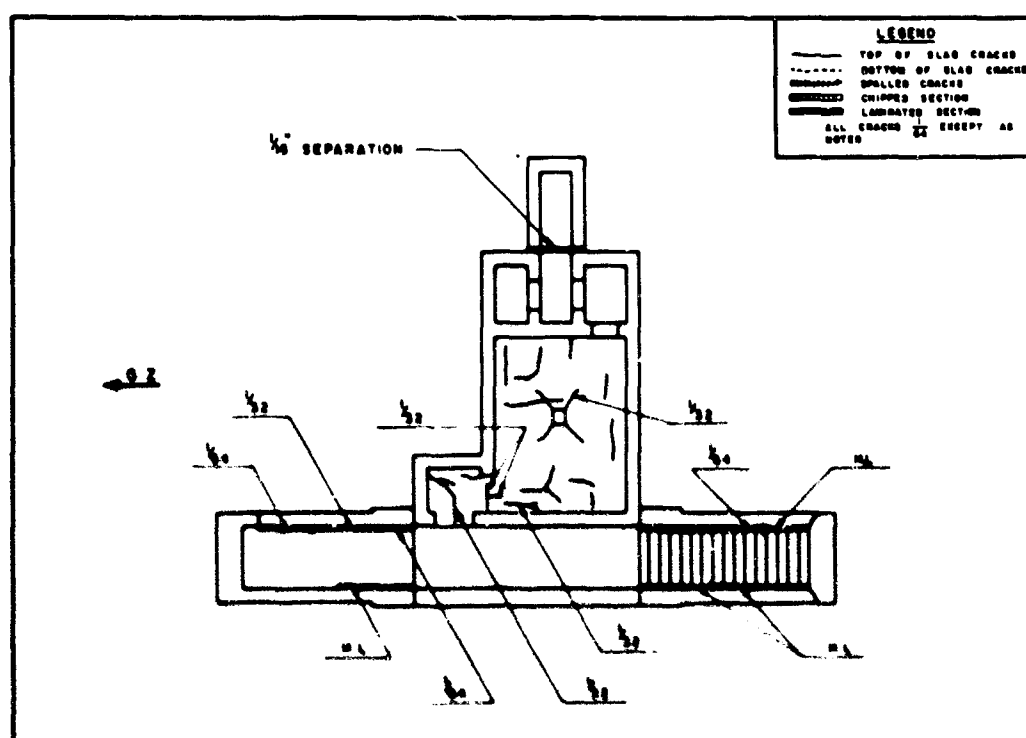
Fig. 3.83—Floor-slab crack pattern (structure RCa).

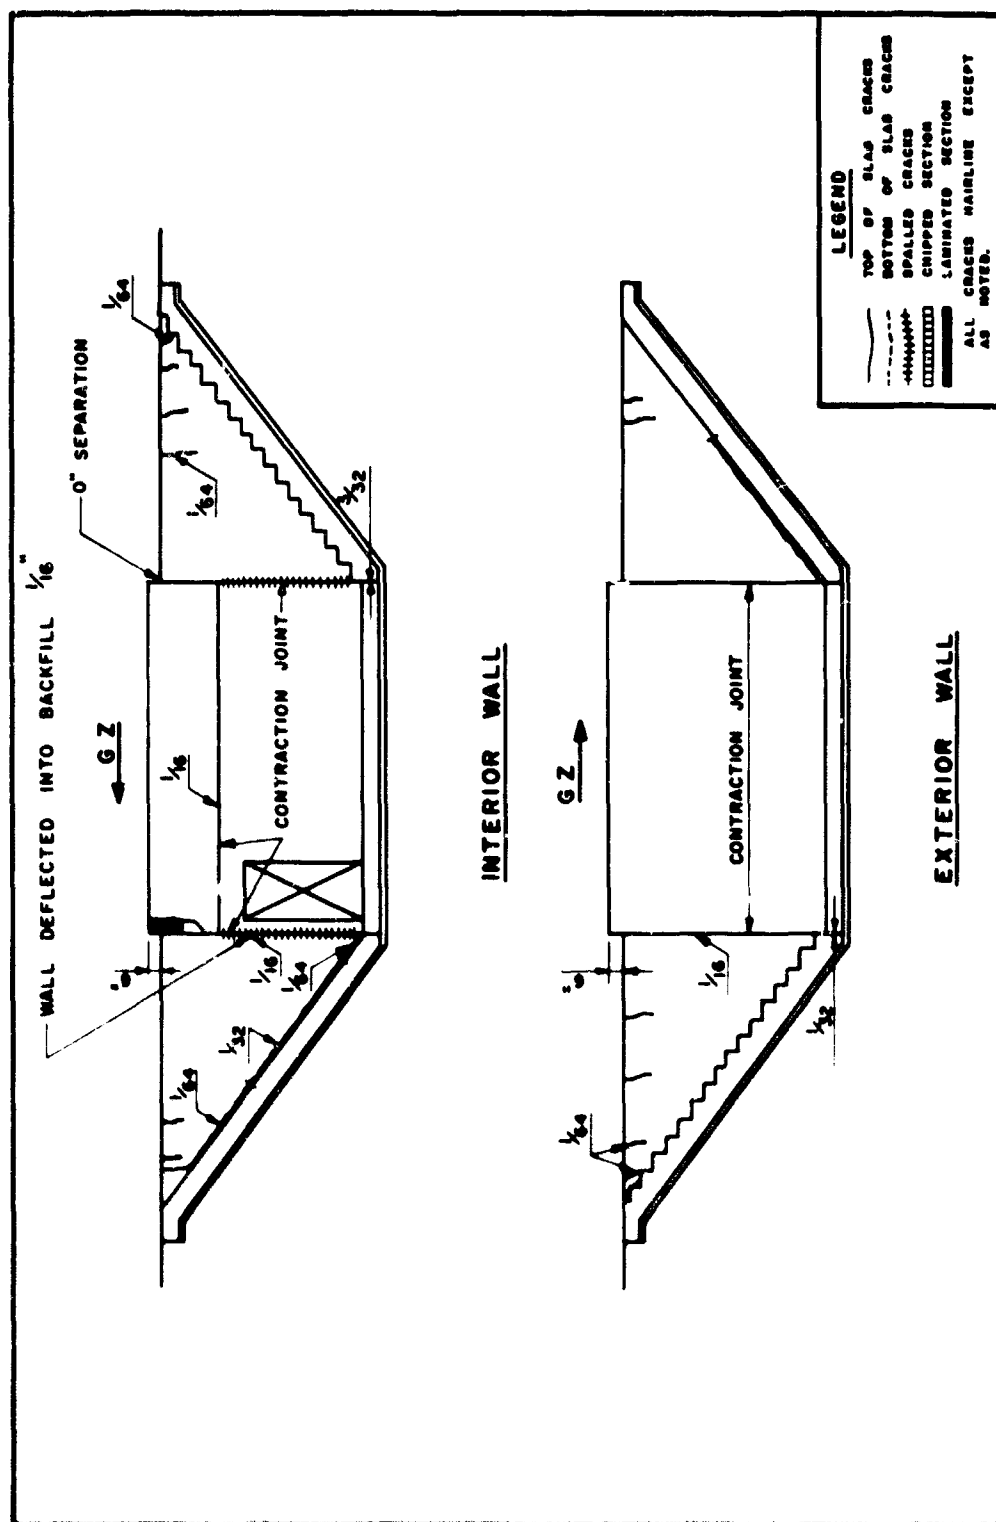
**Fig. 3.84**—Entrance crack pattern (structure RCa).

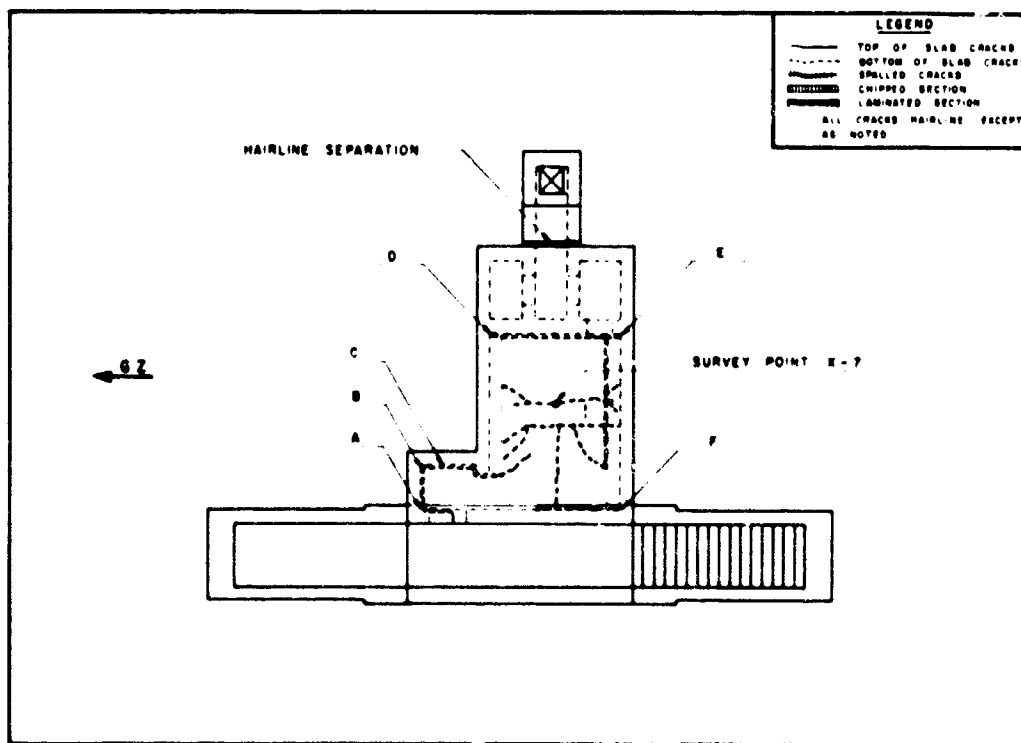
Fig. 3.92—Roof-slab crack pattern (structure RCb).

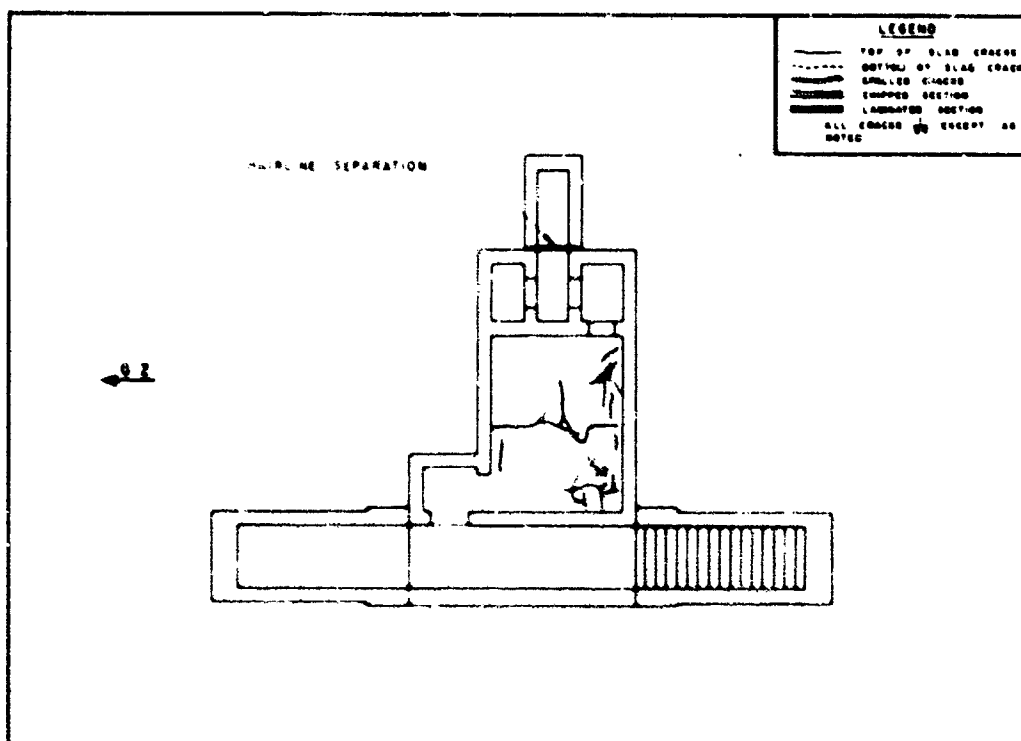
Fig. 3.93—Floor-slab crack pattern (structure RCb).

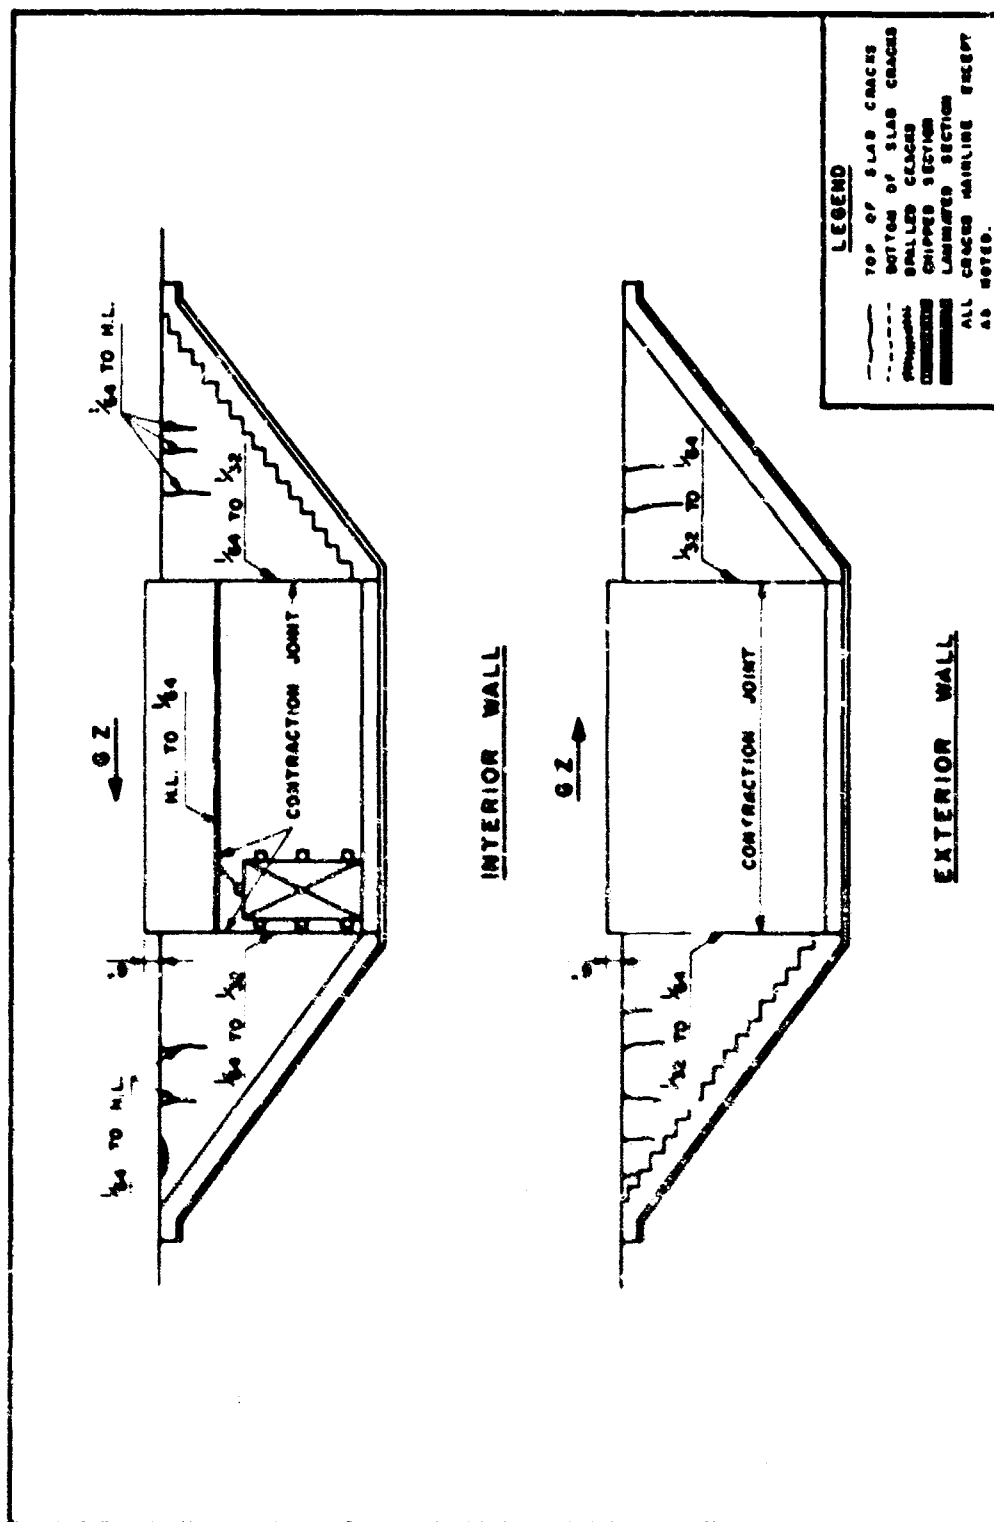
Fig. 3.34—Entrance crack pattern (structure KCb).

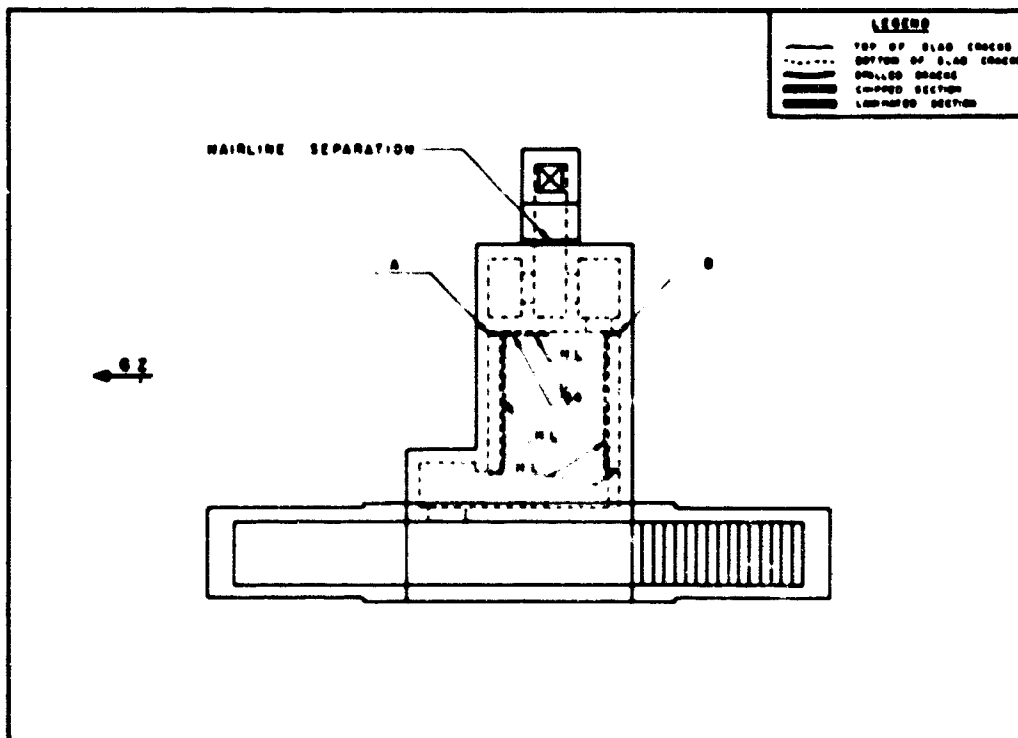
Fig. 3.99—Roof-slab crack pattern (structure RCc).

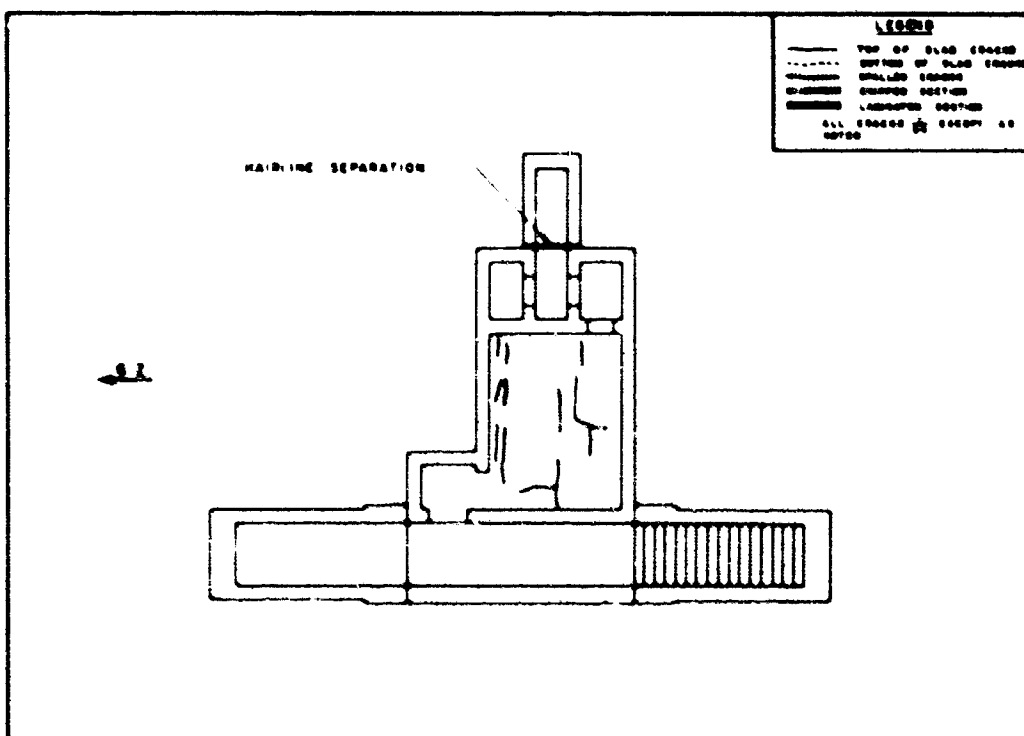
Fig. 3.100—Floor-slab crack pattern (structure RCc).

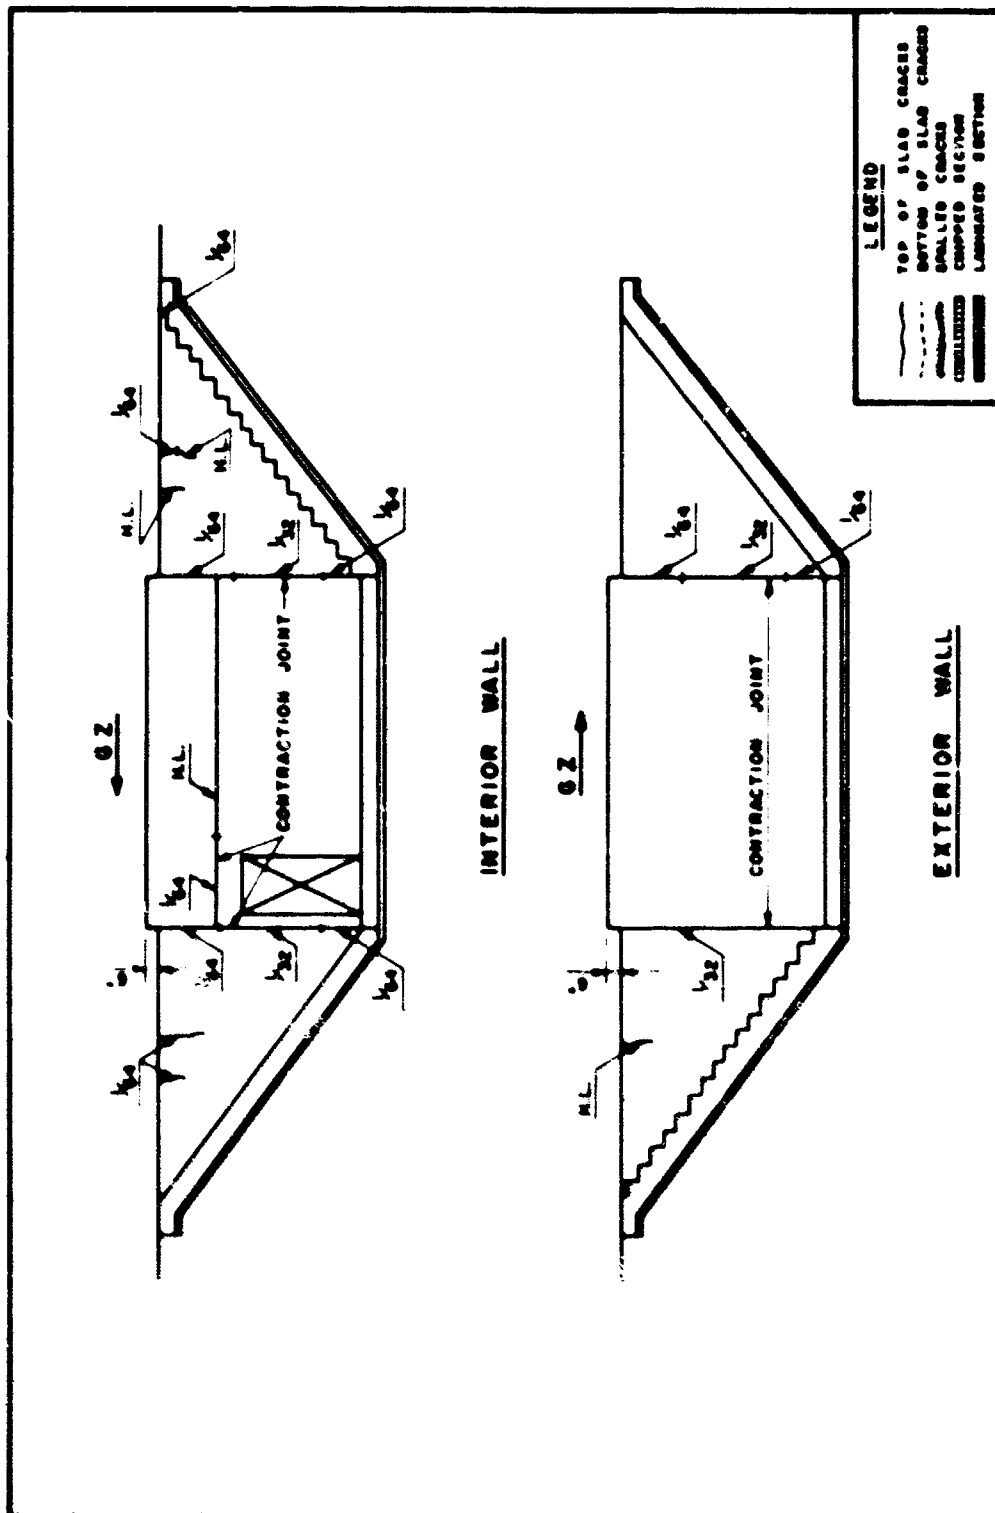
Fig. 3.101—Entrance crack pattern (structure RCc).
